MARINE INVESTIGATION REPORT
M00C0053

CONTACT WITH BOTTOM

BY THE TANKER "ALGOEAST"
AMHERSTBURG CHANNEL, ONTARIO
10 AUGUST 2000

Report Number M00C0053

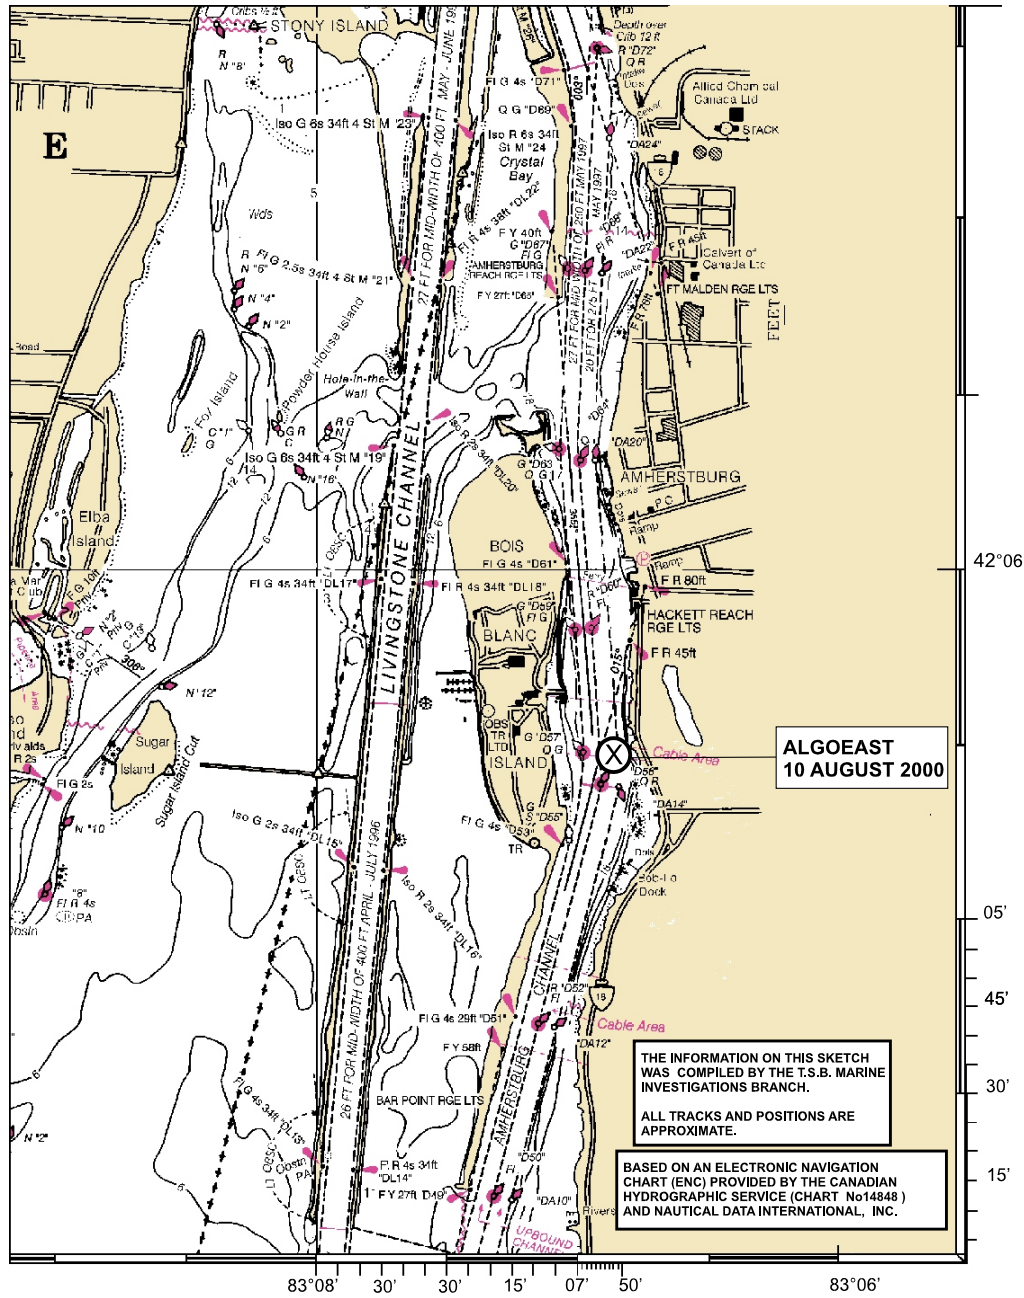
Appendix A – Sketch of the Occurrence Area

When the “ALGOEAST” approached buoys “D 56” and “D57”, the master was looking for the next range on which to steer, that of the fixed yellow lights of the Amherstburg Reach Range. Between buoys “D56” and “D57”, the shipping channel changes direction by 17.5 degrees. At this location, the master delayed altering course to port because he saw two large white lights ahead that he thought could be a range of which he was unaware. The other officers of the bridge team also saw the lights but recognized there was a vessel further upstream crossing the channel from west to east. There was no exchange of information concerning the lights by the bridge team members until the officer manning the starboard radar indicated that there was a vessel up ahead. By that time, the lights of the Amherstburg Reach Range were coming into line.

The master then ordered helm to “port 10”, and followed up quickly with “port 20”. At 2142, as the vessel altered to port, it made contact with the bottom at reported position 42° 05.45’N and 083° 06.91’W, which is east of the eastern charted limit of the deep-draught portion of the channel. The vessel’s speed prior to its contact with the bottom was reported to be 7.8 knots. Upon contact, the master ordered “hard to port”, “midships”, and then “hard to starboard”, and steadied the vessel along the Amherstburg Reach Range.
